My House Is Headed South!

By Paul Wilson, RHI

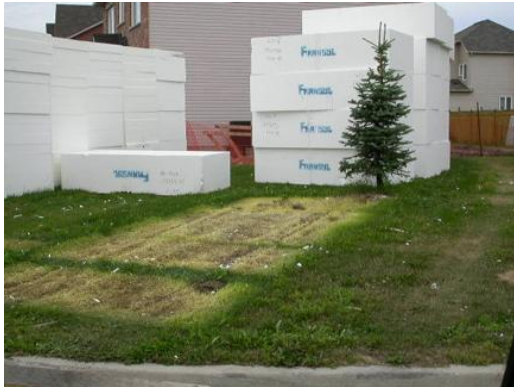
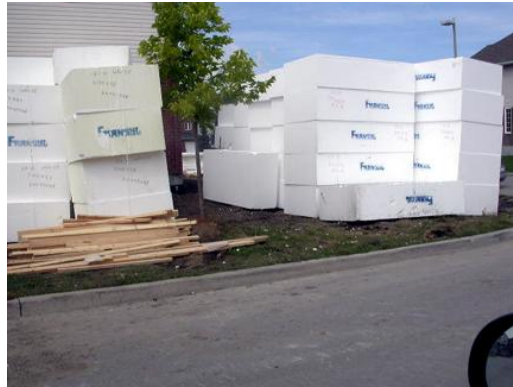
One of the sure telltale signs of remedial work being performed in a subdivision is the evidence of the following, as seen in these pictures below.

All existing yard appurtenances are removed (e.g. planting, furniture, interlock and wood decks etc.).

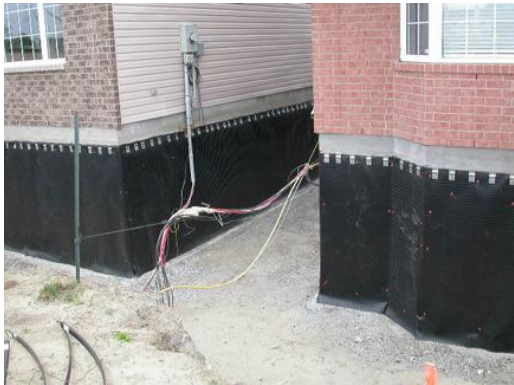
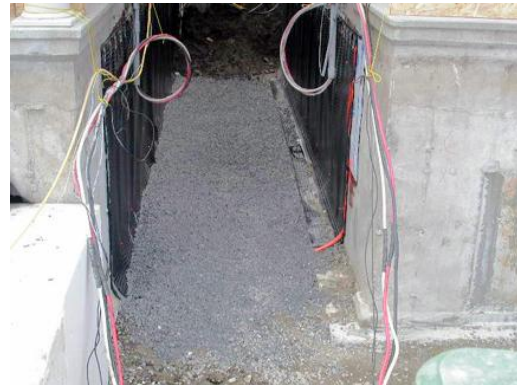
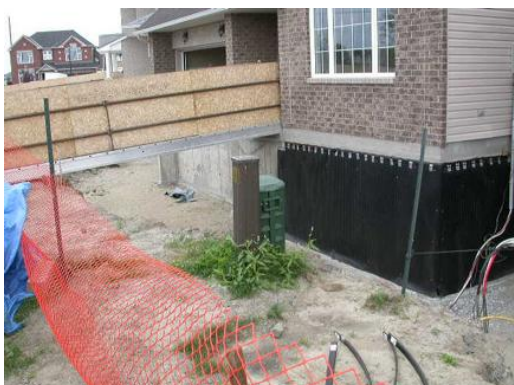
The work begins with the excavation of the soil as directed by the engineer (typically to the top of the footing and about 3 m out from home) and services are suspended as seen here.

A catwalk from the street to the main entrance of the residence is erected. In fact, the excavation looks a little like a rabbit warren once all of the soil from around all of the foundation is removed. Houses stand without

any infill as workers remove every bit soil from around the houses for about 3 metres or so. During this process the drainage tile and moisture barriers are removed and disposed of, exposing the foundation in its entirety.

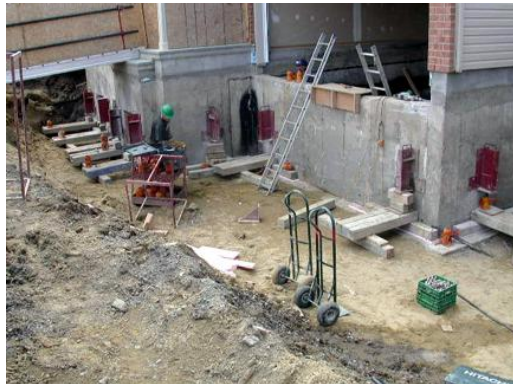
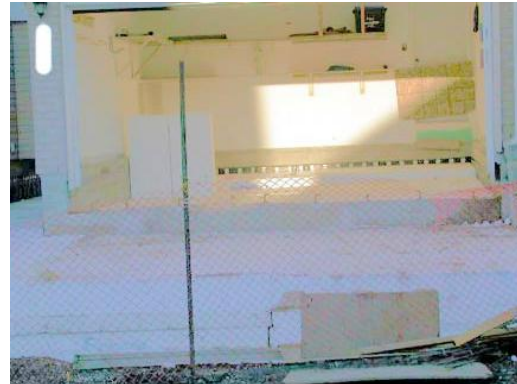
Garage floors are removed and excavated down to the interior footings, as seen below. Below are the before and after photos of the garage area. Access to the home is maintained throughout and there is limited effect on occupancy.

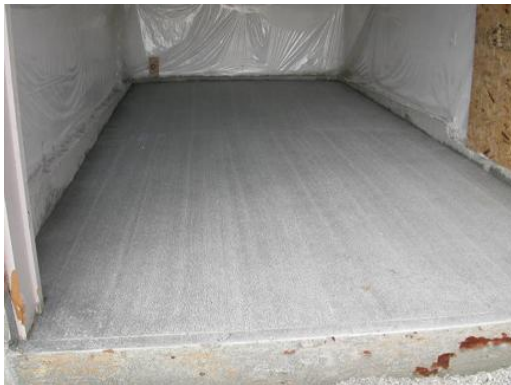
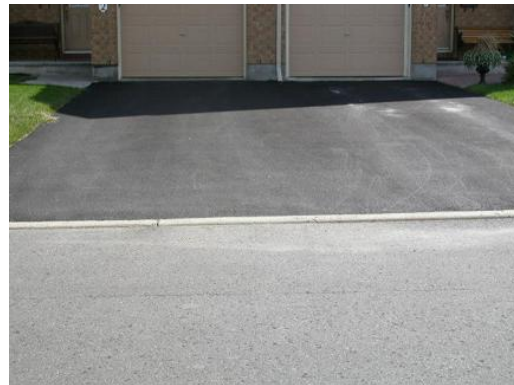
The photographs below are of the completed garage floor and driveway as viewed from the street after completion of the above remediation process. All of the remedial work was done under a building permit and the warranty period odometer reset back to zero for the homeowners involved in this case.
